Climate Change Adaptation Guidance – Infrastructure

# Paths

# Paths – introduction

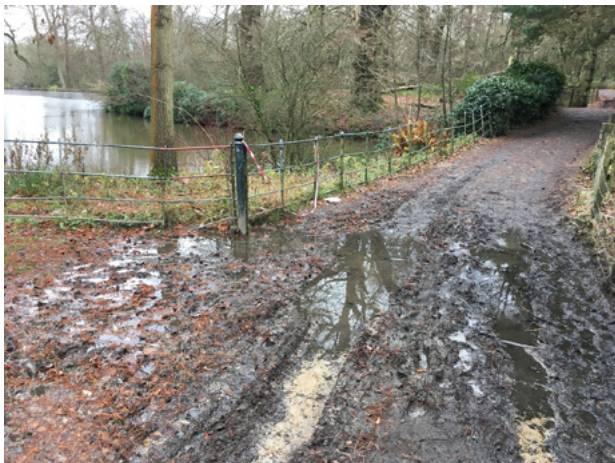
Flooding and rainfall affecting the Henry Moore Path at Kenwood  
(© English Heritage Trust)

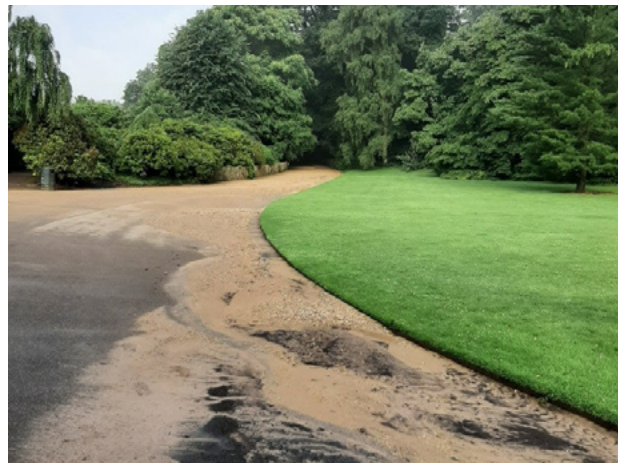
Loose material and binder washed away after heavy rain on this historic drive at Kenwood (© English Heritage Trust)

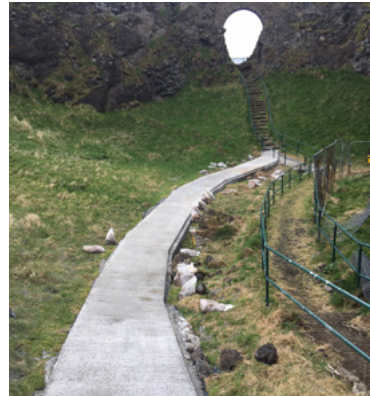
Fundamentally, all of the pattern book options use different methods for binding aggregate, but the unique characteristics, significance, vulnerabilities and use of your specific site may mean different adaptive pathways apply to each site.<sup>1</sup> The worked example below is based on the path around the Sea Plantation at Mount Stewart, Northern Ireland. This asset is vulnerable to sea-level rise, storm events and flooding.

*(Response thresholds are most likely to be based on safety, linked to the level of water ingress during storm-swell events causing flooding of the path and its access from linking infrastructure. The specific trigger points would need to be agreed by both the operations decision-maker and relevant consultants, and consultees such as visitors and path users.)*

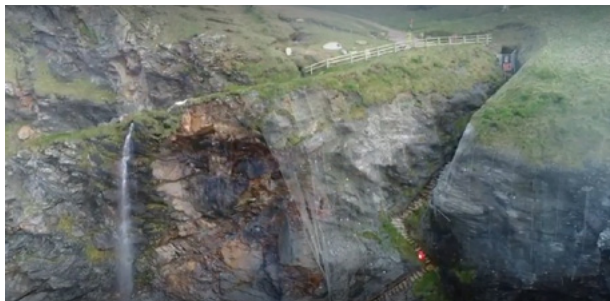
Collapsing cliffs at Carnewas, Bedruthan (© National Trust Images)

Along the coast we see many examples where walks and access routes have been adapted because of cliff collapse, dune mobility and storm damage. At Hive Beach the National Trust moved the path inland because of coastal erosion, but also for the benefit to nature in this location. Sometimes, there is no choice but to close the path due to the lack of an alternative route, such as at Carnewas where increasing instability of cliffs posed a health and safety risk.<sup>2</sup> The path here is likely to be closed because of the considerable cost and safety issues to maintain the route. The rate of cliff collapse is now outpacing the ability to maintain the coastal access.

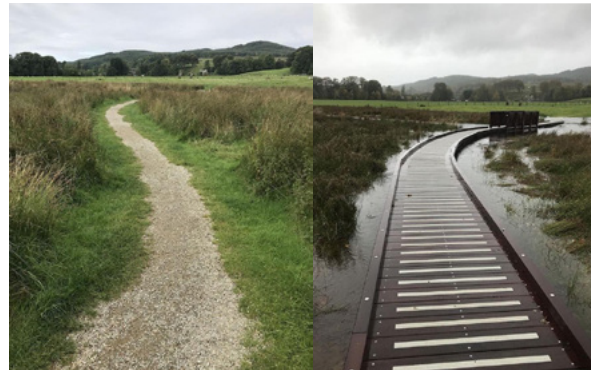
The gravel path in Kilmartin Glen, Argyll, was heavily prone to flooding and the impact is projected to get worse due to climate change. Although the replacement of the gravel surface with a timber walkway will need maintenance, the route is now accessible in all weathers.<sup>3</sup>

The timber walkway in Kilmartin Glen, Argyll (© Historic Environment Scotland)

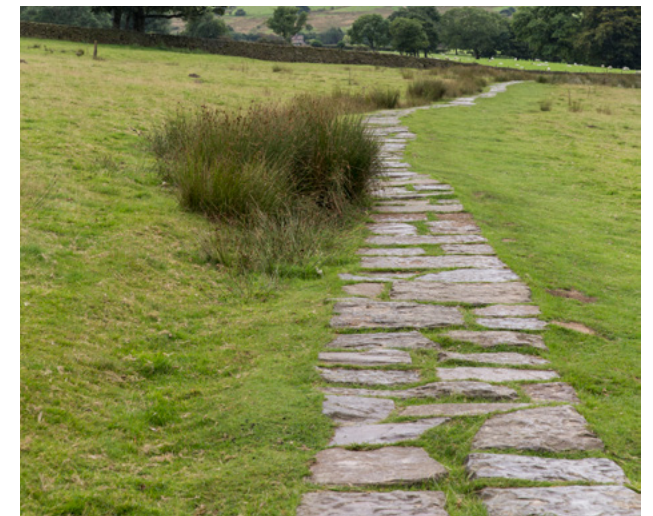
Mountainous paths and heavily traversed, but remote, national trails such as the Pennine Way show how a substantial intervention has been effective for over half a century, even though it was controversial when installed. The path was heavily degraded by frequency of use and worsening rainfall. The stone path has held up well against the elements.<sup>4</sup>

The controversial but effective stone path on the Pennine Way (© National Trust Images)
