National
Trust

Climate Change Adaptation Guidance – Buildings

Historic Building Fabric

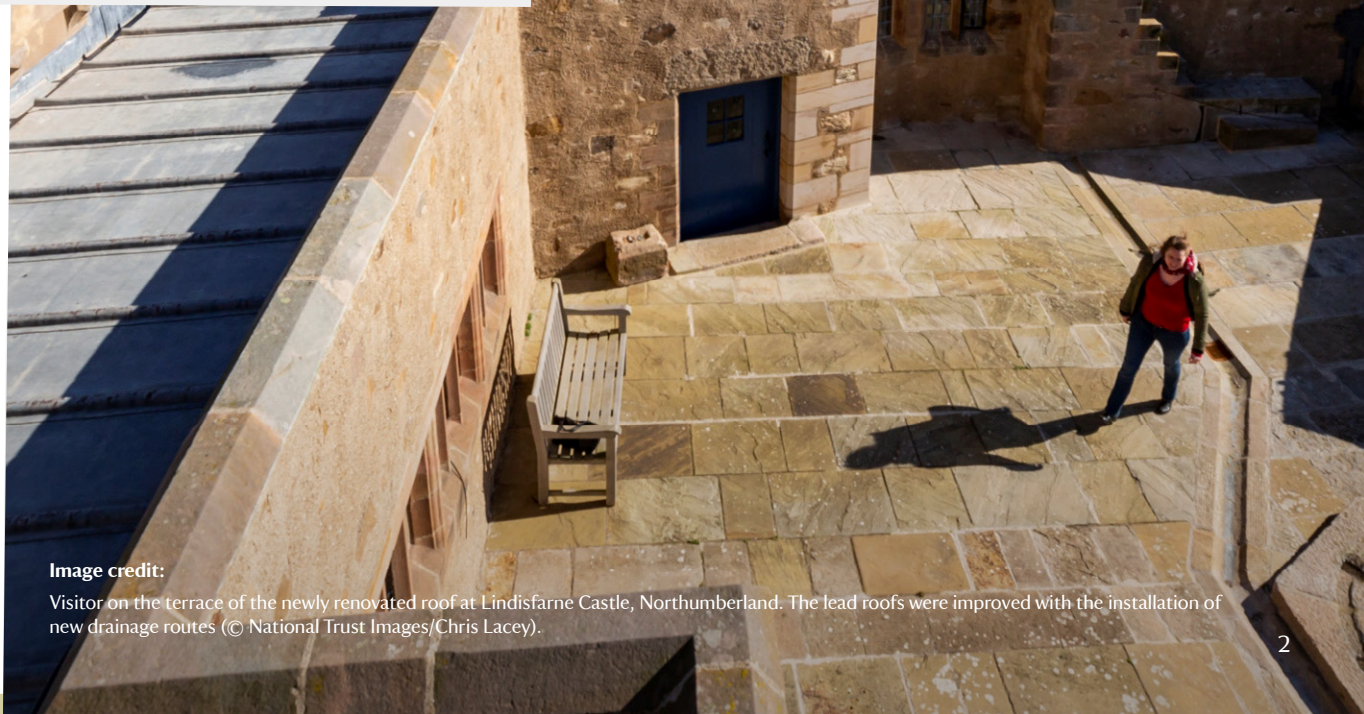
Visitor on the terrace of the newly renovated roof at Lindisfarne Castle, Northumberland. The lead roofs were improved with the installation of new drainage routes (© National Trust Images/Chris Lacey).

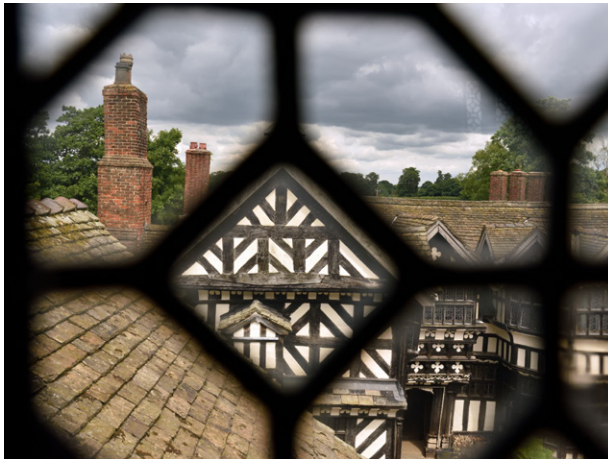
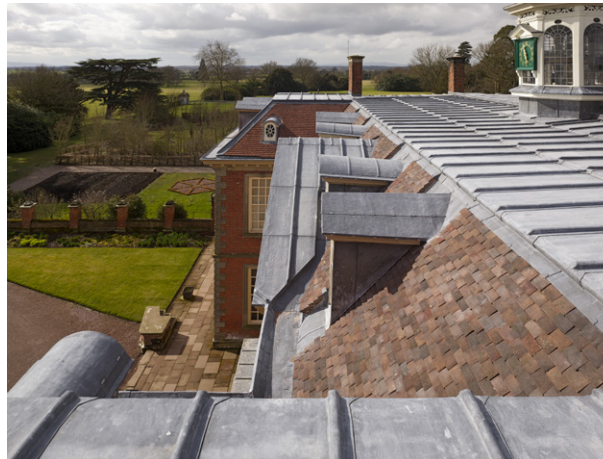
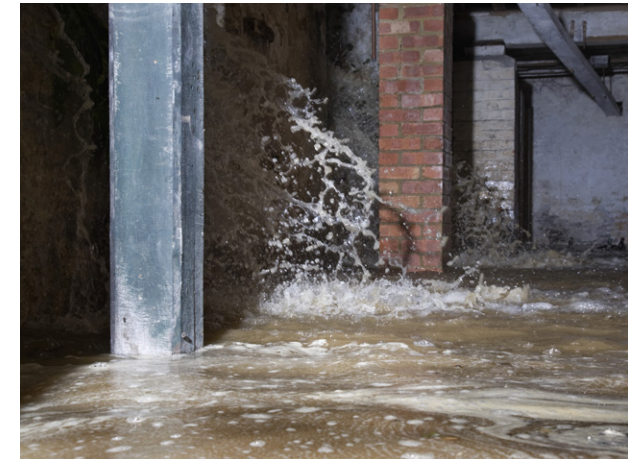
Left to right: A lead window at Little Moreton Hall, Cheshire (© National Trust Images/John Millar); the roof at Hanbury Hall, Worcestershire, with lead flashing and new tiles (© National Trust Images/Dennis Gilbert); water rushing into the house during flooding in July 2007 at The Vyne, Hampshire (© National Trust Images/John Hammond).

Overheating	<p>Lead buckling in windows and on roofs.</p> <p>Cracking of render, open joints, missing or crumbling joints.</p>	<p>Repair of lead, replacement with higher-coded lead where appropriate. On roofs, increased movement could be accommodated through changes to detailing, e.g. size of bays.</p> <p>Appropriate material and finish of masonry repointing; improved weathering detailing in architectural elements; external coatings on masonry, e.g. harling or lime render.</p>
Drought	<p>Shrink/swell causing movement of foundations and masonry structures (visible as cracking in joints).</p> <p>Elevated risk of wildfire during prolonged hot and dry periods.</p>	<p>Take measures to improve drainage of water away from the building, to avoid saturation of foundations during wetter weather, which will help minimise extent of shrink during drier periods.</p> <p>Maximise water storage capacity; develop and implement a drought management plan. See separate guidance Water: Water Sourcing and Efficiency. Develop a wildfire management plan in collaboration with local partners. See separate guidance Places: Wildfires.</p>

Hazard	Impacts	Options
High winds	<p>Damage to roofs and windows from high winds, resulting in water ingress; damage caused by wind-driven rain.</p> <p>Damage to building fabric from nearby falling trees.</p>	<p>Increase checks and monitoring of building elements after storms or high winds, looking especially for loose tiles, damage to rainwater goods and signs of water ingress internally caused by either storm damage or wind-driven rain.</p> <p>Regular monitoring of surrounding trees – check for signs of pest and disease or weakness; where compromised, careful removal or replanting of trees to retain as key features of the designed or evolved landscape.</p>
Sea level rise	<p>Increased likelihood of flooding and coastal erosion.</p> <p>Increased salt-related damage to building fabric.</p>	<p>Flood prevention should be combined with measures to minimise flood damage, such as flood stop boards and moving electrical supply and outlets to a higher level. In cases of extreme repeated flooding and/or coastal erosion, explore options for adaptive reuse/release with a conservation professional.</p>

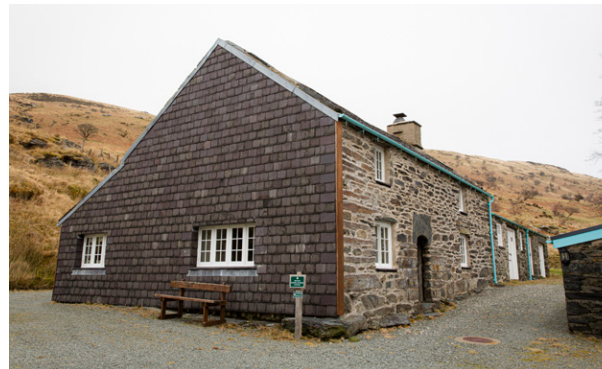
The exterior of Dyffryn Mymbyr cottage, Conwy, with slate hanging on the gable wall (© National Trust Images/Annapurna Mellor).

The worked example on the right¹ is based on a National Trust residential let estate building at Dyffryn Mymbyr, Conwy, Wales. The internal finishes of the stone gable wall were suffering from penetrating wind-driven rain. With more frequent and intense rainfall, the problem persisted despite maintenance, monitoring and several attempts at re-pointing. Learning from the vernacular architecture style in Snowdonia, we decided to redesign the materials and details and install 'slate hanging' on the exposed end of the building. This was sympathetic to the character of the building and typical of the locality, so listed building consent was granted. The pathway below considers hypothetical options for the longer term

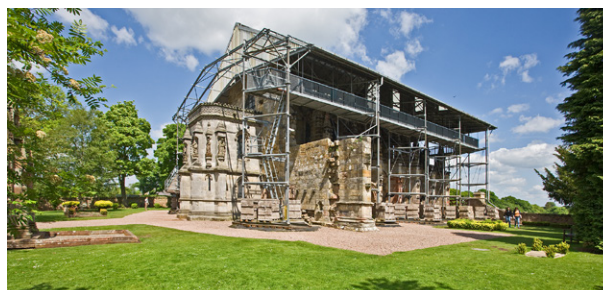
Top to bottom: aerial view of Blickling Hall, Norfolk (© National Trust Images/Annapurna Mellor); Fountains Abbey, Yorkshire, with the river Skell in the foreground (© National Trust Images/ Chris Lacey); Rosslyn Chapel, Midlothian, with canopy (© Rosslyn Chapel Trust/Antonia Reeve).

By the late 1990s, [Rosslyn Chapel, Midlothian](#) was suffering due to ineffective rainwater disposal and a lack of heating in the building, which resulted in the stone becoming

porous and saturated, and problems with damp and algae growth. A protective canopy was built to protect the structure; this remained in place for 10 years and facilitated high-level visitor access. Adaptations to the building fabric itself included covering the exposed stone roof with lead, adding a rainwater system and biomass heating to manage relative humidity. The protective canopy was removed in 2010.
