Climate Change Adaptation Guidance – Gardens and Parks

Lawns and Grass Paths

Lawns and grass paths – introduction

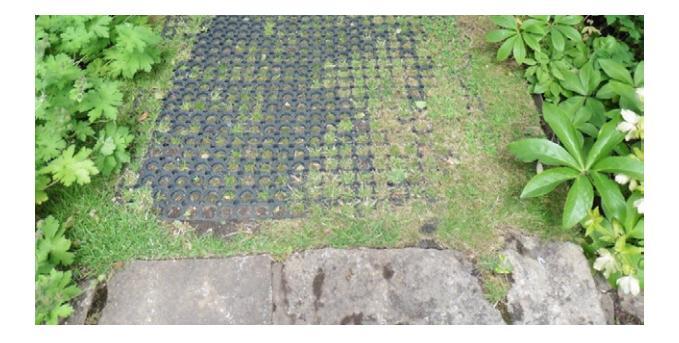
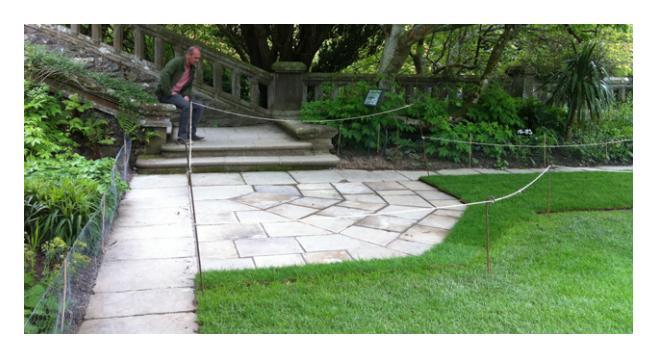
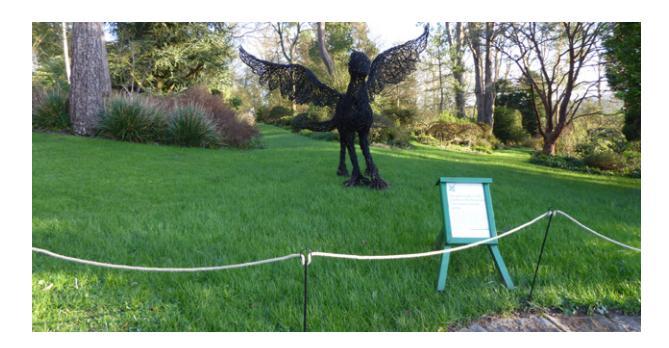
Left to right: Rubber matting showing through where it has been used to try to manage wear on a grass pathway at The Courts, Wiltshire (P. Alexander); paving at Bodnant, Conwy, to resolve worn pinch point on lawn (R. Bevan); lawn at Knighthayes, Devon, closed for recovery with neat rope barrier and explanatory sign (R. Bevan).

Turf reinforcement – various grass protection mats are available and widely used to protect the growing points of grass from wear in wet conditions. They are usually rubber or plastic and can be made of recycled and recyclable materials. These mats are best used as a temporary solution as they are not effective in the long term and can be unsightly.

Paving – where appropriate, pinch points and paths that are required to provide access but cannot support it may need to be paved. Planning permission will probably be required and choice of design and materials must be carefully considered. A heritage impact assessment may also be needed in historic gardens, parks or designed landscapes.

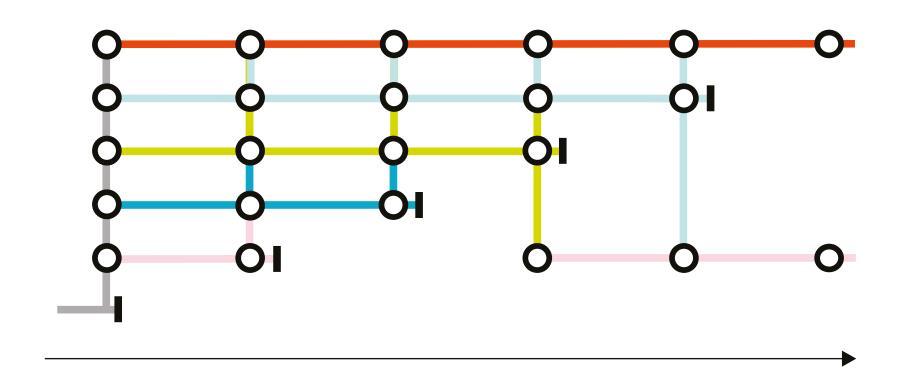
Change path surface Stepping-stones (if appropriate) Improve drainage beneath turf Temporary matting (if necessary) Temporary closures/alternative routes Re-turfing/re-seeding in the spring Time/frequency and intensity of wet weather

(Response thresholds are most likely to be based on visitor complaints and inaccessibility of paths because of damage to turf from saturated conditions throughout the winter and shoulder months. These factors are balanced by site operational behaviours and requirements. The specific trigger points would need to be agreed by the operations decision-maker and relevant consultants and consultees such as the gardeners and rangers working at a site. Design and significance of the asset might impact your thresholds and options within the Dynamic Adaptive Policy Pathway.)

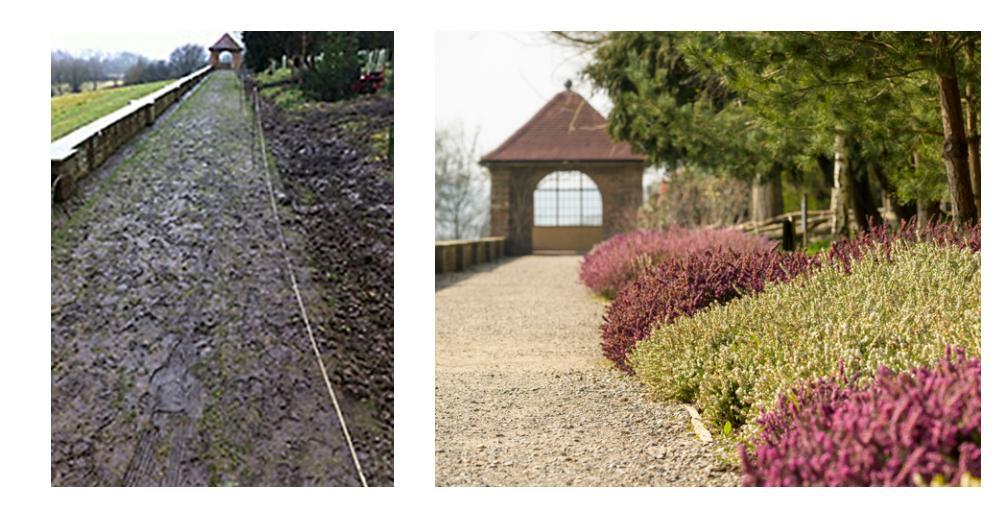
Left to right: A waterlogged grass path on the top terrace at Standen following a busy but wet Easter (M. Bufin); the same path after resurfacing with compacted gravel (© National Trust Images/Chris Davies).

At **Standen in West Sussex**, a turf path along a terrace frequently became churned and unusable, as rain water collected there and drained slowly. After discussion with planners and the curator, the turf was replaced with a hard path. Compacted type 1 gravel was used and the final surface finish is yet to be installed. Crucially, drainage was also required to allow water coming down the terrace to escape through the wall.
